RAILWAY INVESTIGATION REPORT
R04W0035

YARD DERAILMENT

CANADIAN NATIONAL
SYMINGTON YARD ASSIGNMENT YATS-02-17
MILE 145.20, SPRAGUE SUBDIVISION
WINNIPEG, MANITOBA
17 FEBRUARY 2004

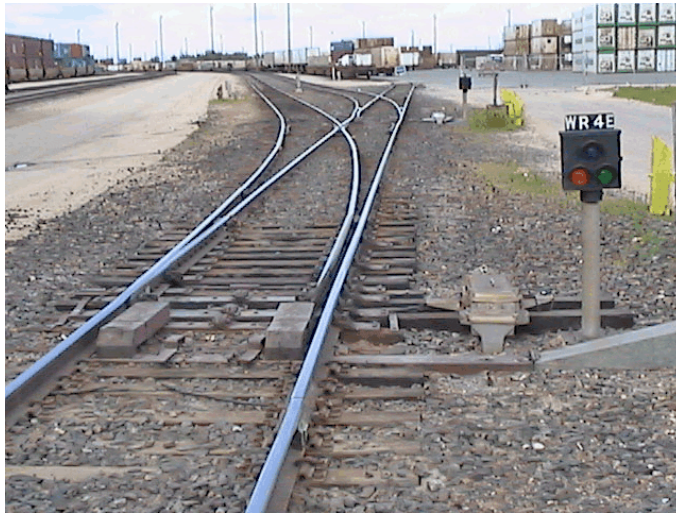
The crew assumed ground control of the power switches³ from the yard tower. These switches control the east end of the west receiving (WR) tracks. The locomotive coupled to the cars on track WR04 and then pulled them eastward onto the switching lead. The vehicle followed the movement out of WR04 at which time the Beltpack operator observed the adjacent track (WI03) to be clear. He brought the movement to a controlled stop on the switching lead track, just east of electric power switch WR4E (see Photo 1).

Photo 1. View looking westward into classification tracks at switch WR4E, Symington Yard (TSB photo). Switch aligned for movement into track WI03.

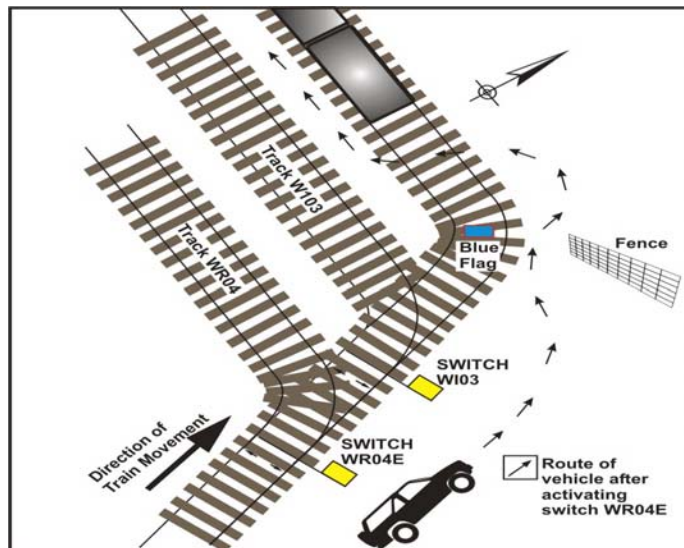
Figure 1. Symington Yard, west receiving tracks

With the movement stopped, the vehicle drove eastward along the north roadway, then turned westward to stop alongside switch WR4E. The Beltpack operator exited the vehicle and walked in front of it to switch WR4E. He pushed the button on the side of the switch stand to engage the power switch to line it for track WI03. The Beltpack operator observed the switch points line for the intended route and believed that he had seen a green switch target light. The Beltpack operator returned to the vehicle, waited briefly, and was then driven westward alongside track WI03, approximately 400 feet ahead of the movement (see Figure 1).

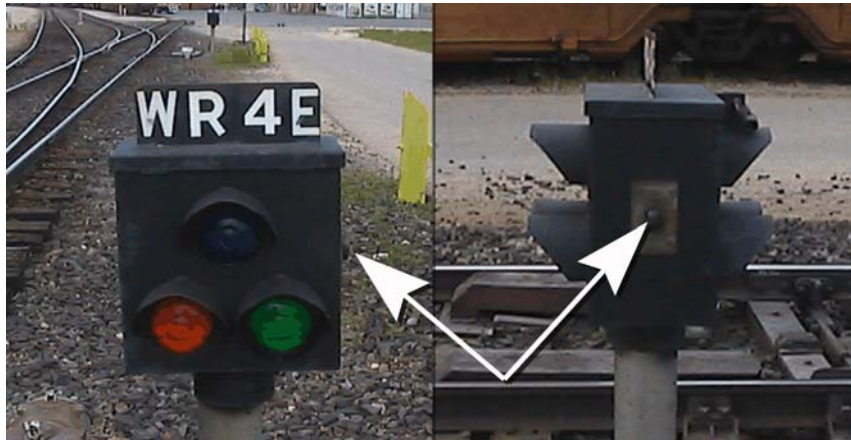
- 1148 – Switch WR4E was manually activated by push button to line it for track WI03 (see Photo 2). The switch target lights did not illuminate, indicating that the switch had not locked and that the switch was positioned at some point in mid-throw.

Photo 2. Two views of switch WR4E (left: looking west, right: looking south). Arrows indicate the location of the manual activation button. Switch target lights are not visible when standing to the north side of the switch, looking south.

The switch malfunction was consistent with a loss of dynamic snubbing, which is known to be caused by electrical resistance from condensation, frost, or carbon build-up on the contacts within the circuitry. Considering that the box containing the circuitry was not heated and that the temperature at the time of the derailment was -8°C, it is likely that condensation or frost on the contacts caused the switch to malfunction. Had the operator observed that the switch target lights did not illuminate, re-activating the switch may have corrected the problem.

The target lights are designed to be viewed from the point of an approaching movement. As such, each light is covered by a sun shade and located below the eye level of a standing switch operator. This design limits the ability of an operator standing beside the switch stand to observe the target light without stepping in front of the switch box.

2. When activated, the switch lined for the movement into WI03, but did not properly lock. It is likely that frost build-up on the switch contacts resulted in a loss of dynamic snubbing and caused the switch to malfunction.

3. In combination, the switch target light design and the position of the vehicle alongside the switch reduced opportunities to view the switch target light and correct the error before resuming the movement.
